TRACKSTER

SERVICE BULLETIN

20

STARTER ACCESS BOOT

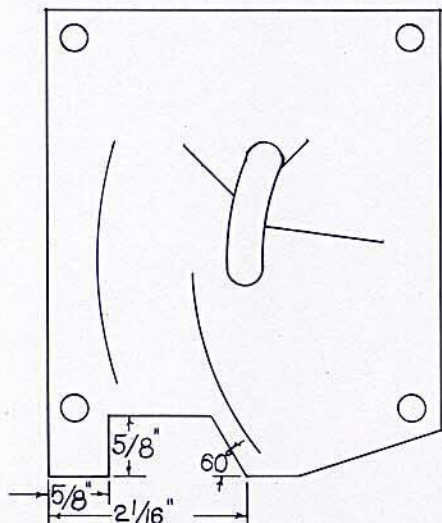
FIGURE 1

It has been brought to our attention that in some cases there is insufficient clearance between the starter access boot and the stationary pulley on the starter.

If this is encountered, it is recommended that the boot be removed and re-installed on the engine side of the fire wall. It will be necessary to cut out a small portion of the boot to make clearance for the adjusting bracket. See Figures 1 and 2.
