TRACKSTER

SERVICE BULLETIN

23

TRANSMISSION CONTROL ARM INSTALLATION

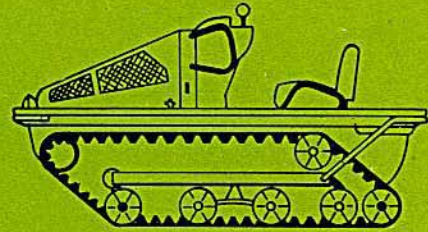
Sundstrand Hydro-Transmission has informed us they are receiving units from the field with the retaining washers badly bent. This was caused by an impact force created during assembly of the control arm to the trunnion shaft of the transmission.

When installing the control handle, Sundstrand does not advise the use of any impact force being applied, such as hammering the handle onto the shaft. Any force applied in this manner puts undue pressure onto the shaft and, consequently, onto the washer. This force bends the washer causing the seal to leak.
