TRACKSTER

SERVICE BULLETIN

PARKING BRAKE

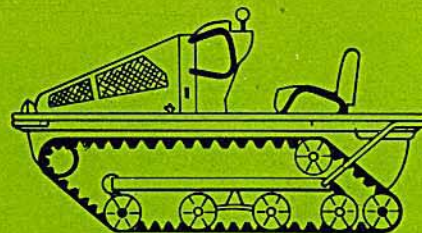
A grease fitting has been added to the parking brake pivot shaft housing to provide a means of lubrication.

All Trackster vehicles shipped from the factory after July 15, 1972 have a grease fitting located on the backside of the pivot shaft housing.

A parking brake with a grease fitting should be lubricated every three months with a grease gun and lithium-base grease.

All Trackster vehicles not equipped with a grease fitting can be modified by purchasing a new "Bracket with Shoe," Part No. 882371, for replacement.
